**LETTER REPORT  
FOR  
CLARK OIL REFINERY  
BLUE ISLAND, COOK COUNTY, ILLINOIS  
TDD: SO5-9802-018  
PAN: 8F1801PIXX**

**April 3, 1998**

Re: Clark Oil Refinery - Blue Island  
Blue Island, Cook County, Illinois  
TDD: S05-9802-018  
PAN: 8F1801PIXX

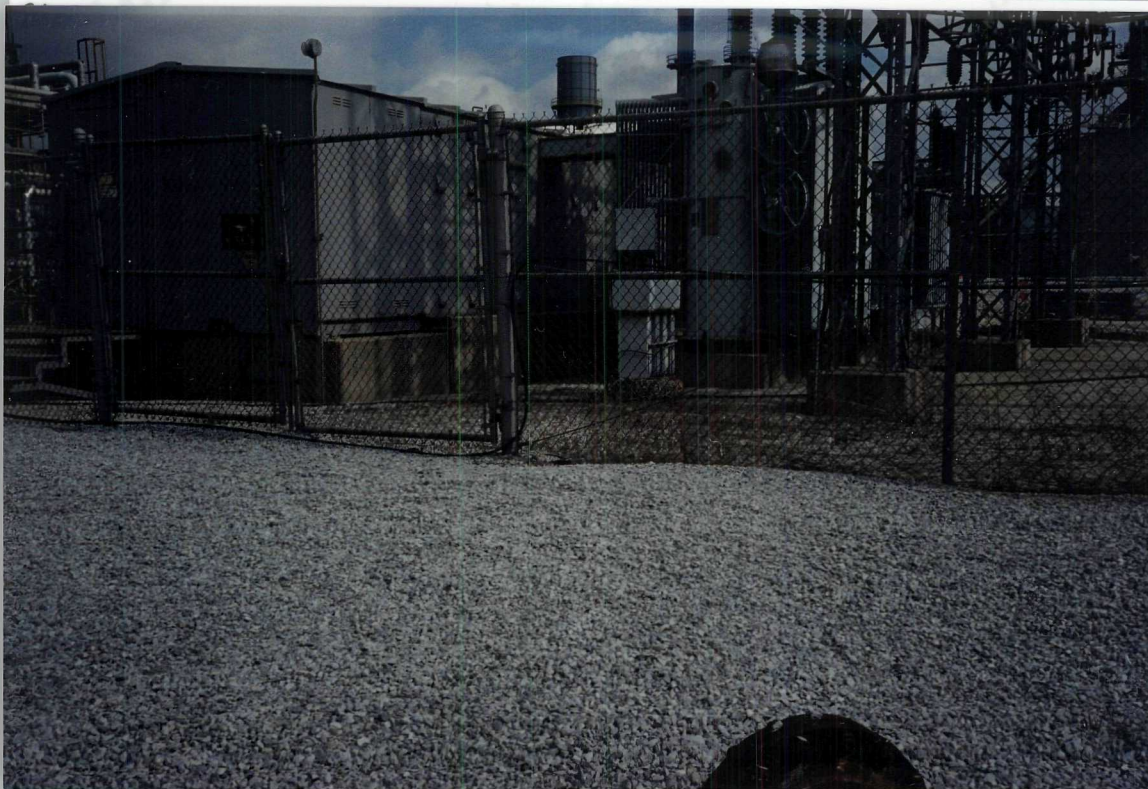
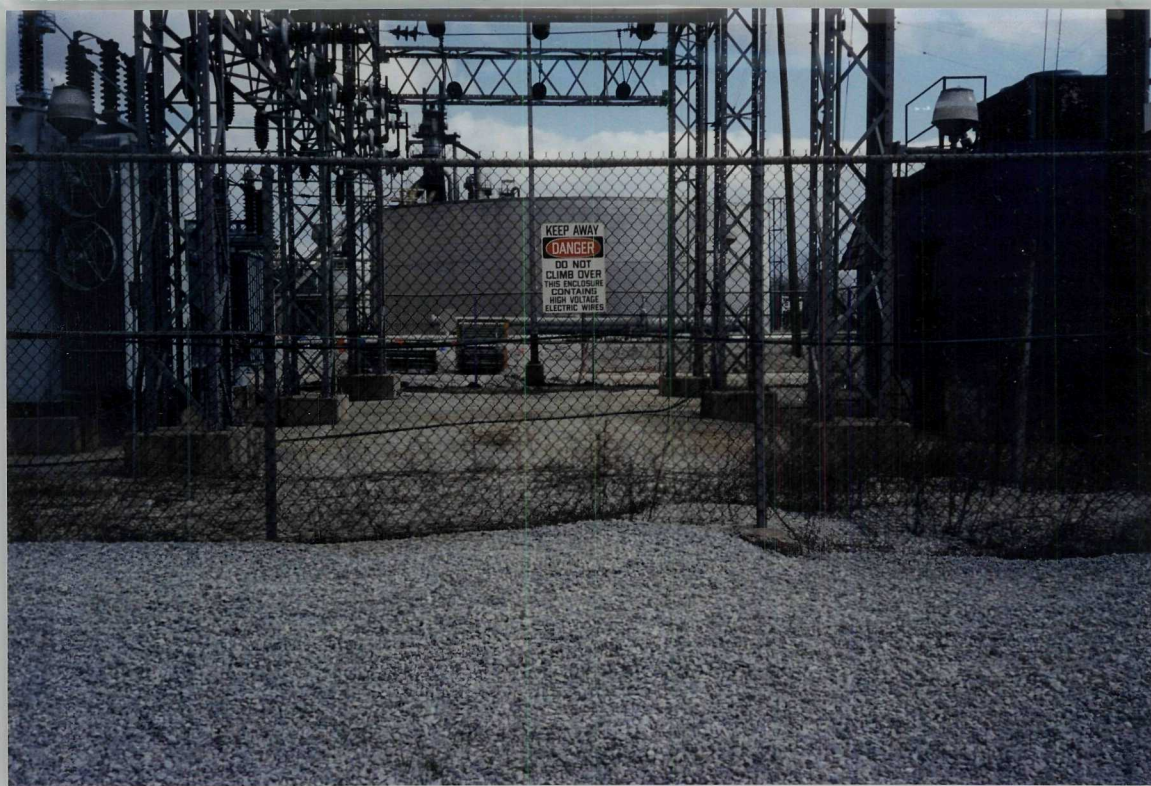
**SITE:** Clark Oil Refinery  
**LOCATION:** Blue Island, IL  
**SUBJECT:** Power transformers 9 and 10. Transformers located behind old office building. The area slopes towards 131st Street.

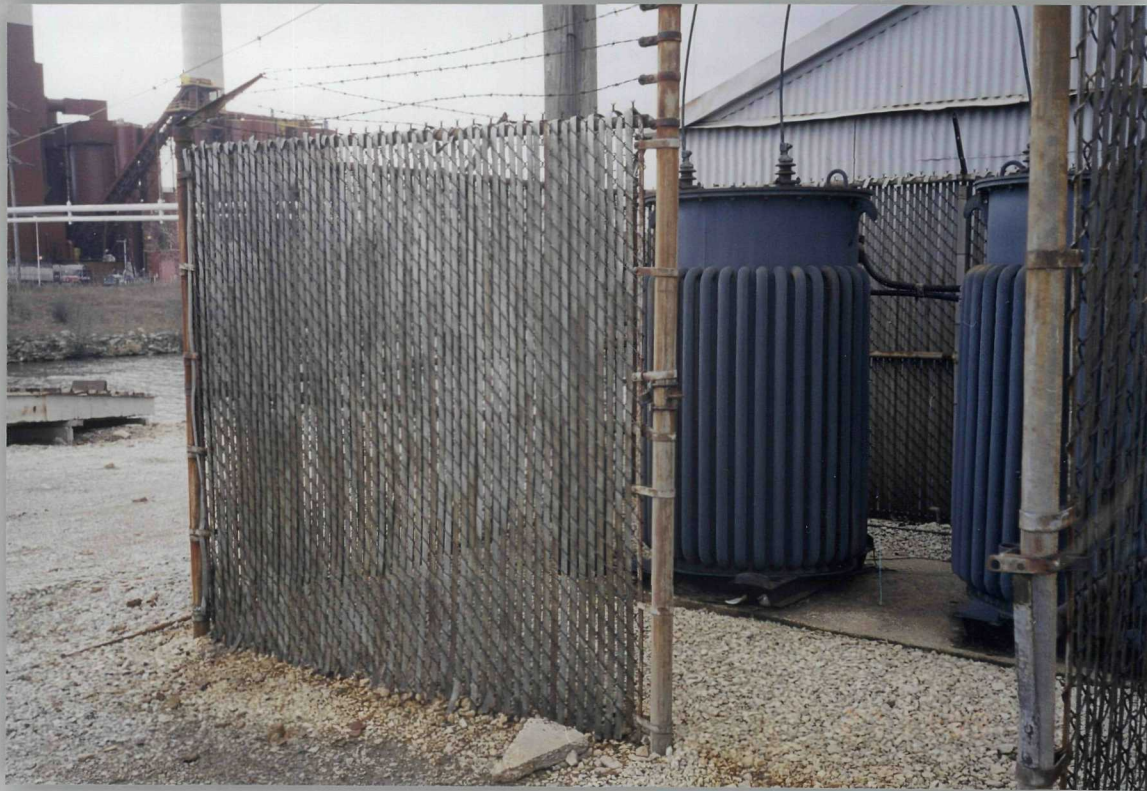
**TIME:** 11:55 **PHOTO:** 25  
**PHOTOGRAPHER:** Kirchner

**SUBJECT:** Power transformers located near canal.

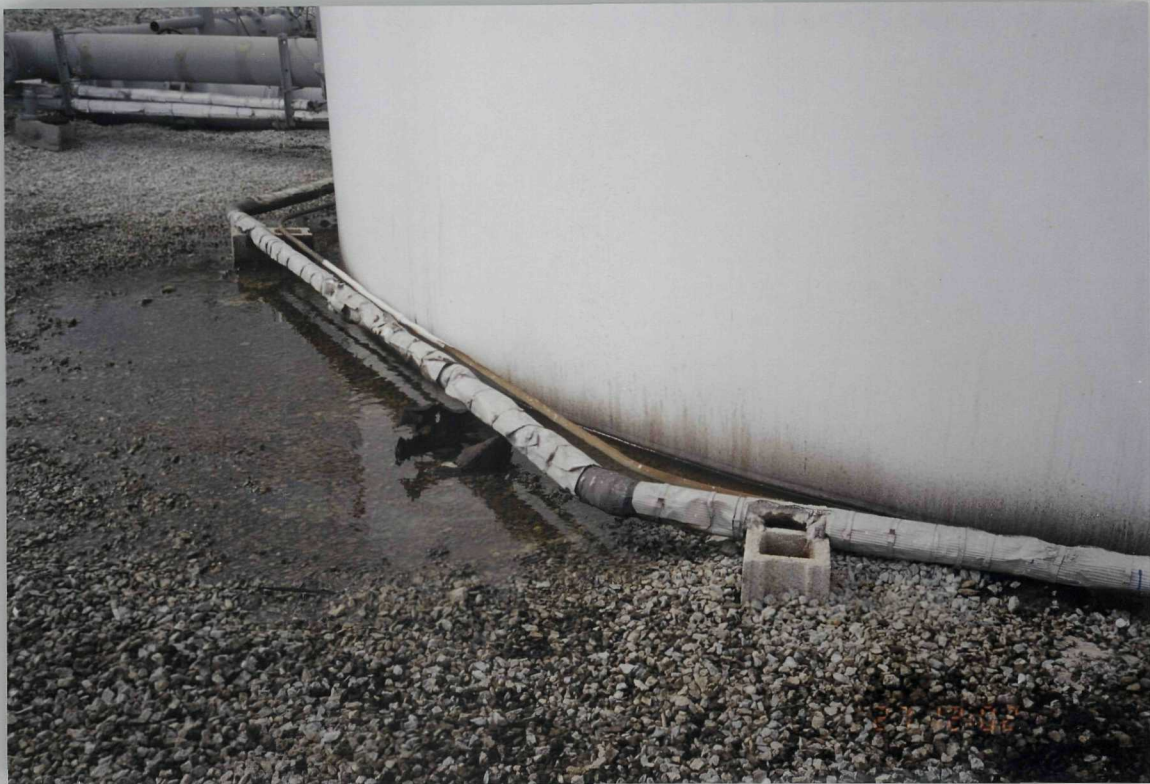
**TIME:** 11:55 **PHOTO:** 26  
**PHOTOGRAPHER:** Kirchner

While still in this area, START Kirchner and Mr. Huval returned to tank 59. START Kirchner noted that the piping to tank 59 was supported by cinder blocks (photo 27). The rusted can in the picture was not supporting the pipe and was merely located under the pipe. The insulation around the pipe was worn away where the pipe came in contact with the cinder block.

**SUBJECT:** Tank 59 tank support by cinder block, which is not located by rusty can. The area shown in this photo is the same area represented in photo 15 from the March 1997 inspection.
